SUSPENSION MAXX **MAXX LINK** HEAVY DUTY SWAY BAR LINKS

2001-2007 Toyota Sequoia Rear sway bar links

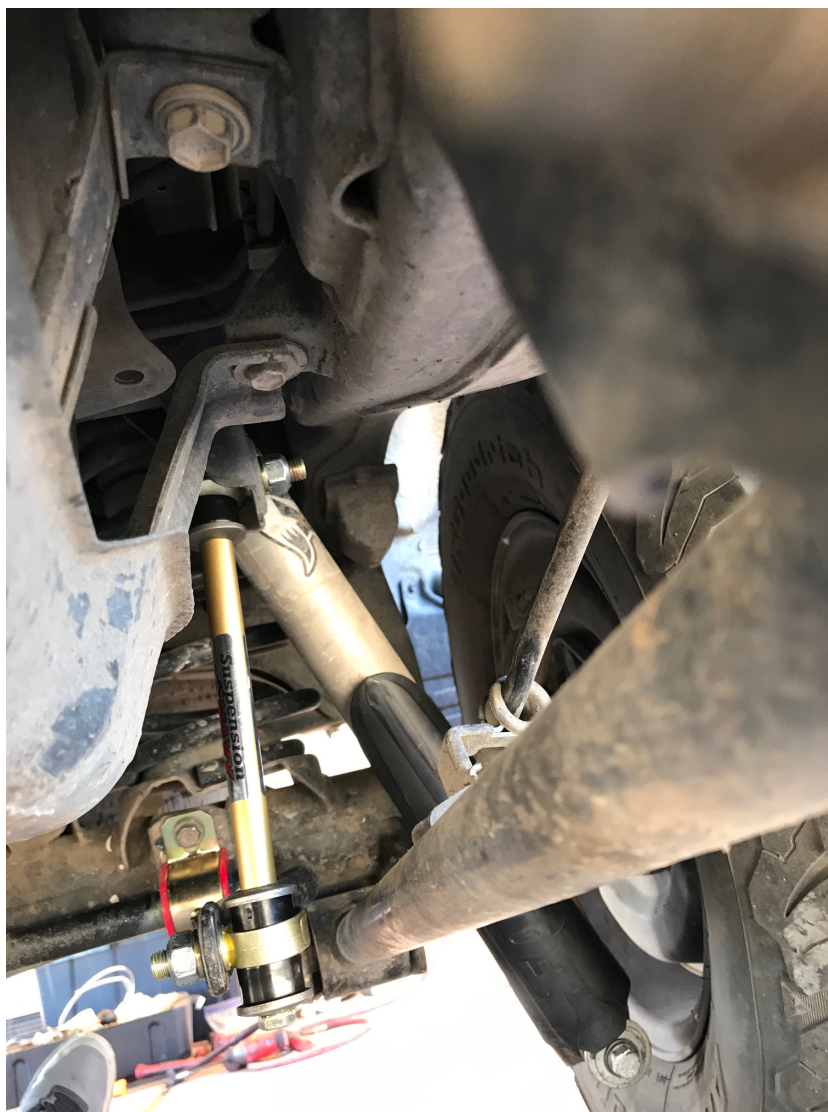
Insert Maxx Link through control arm / sway bar. Install supplied lockwasher and start retaining nut. Continue on opposing side. DO NOT tighten vertical nut to compress bushings further. The MAXX Link is pre-tightened. View MAXX Link and rotate as needed to center lower concave/convex bushings. Hold MAXX Link in place and torque retaining nut to 65 ft. lbs. Re-check sway bar link alignment.

Remove worn / damaged link use caution when removing. Inspect for evidence of loose attaching hardware, repair or replace as needed. (Note assemble and install MAXX Link on both sides of the vehicle before final tightening this allows self aligning of bushings) (Note: Equalize the vertical angle on each MAXX Link by loosening sway bar frame bushing clamps and repositioning bar side to side as needed)

(Note: Equalize the vertical angle on each MAXX Link by loosening sway bar frame bushing clamps and repositioning bar side to side as needed) Retighten all fasteners to factory specifications.
